The Fall and Jump of the

# Douma Bed Cylinder

An emblematic case study in 9 steps

by Michael Kobs

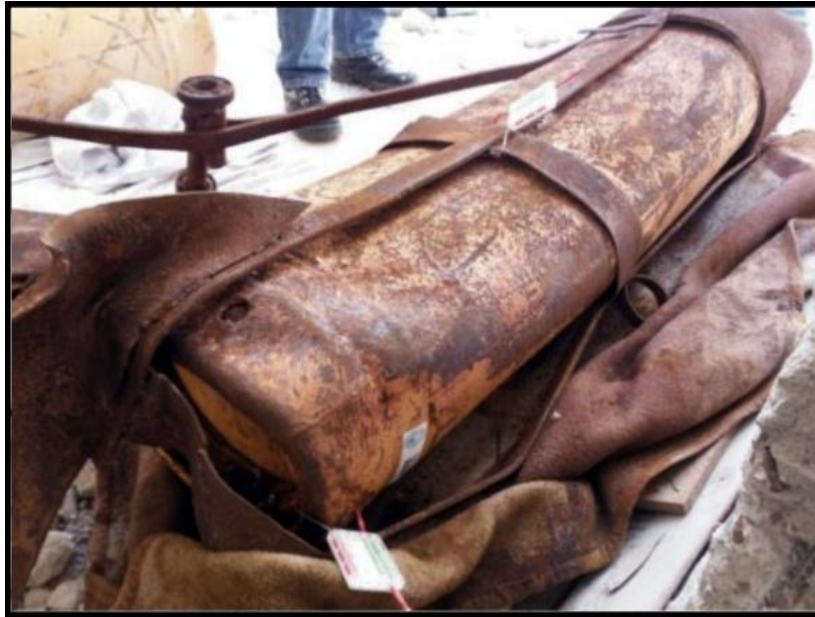
As can be seen in the picture, this armour was bent with the fins around the rear end of the cylinder, while the fin was still reasonably upright. In the FFM scenario, the armour must therefore have already slipped before the (hypothetical impact). This is not impossible either, but it is still unlikely. What is impossible, however, is that the steel of the cylinder has been significantly flattened, while the sheet metal of the fin above it is only slightly bent. How should the force of the concrete act on the cylinder over a large area if a sheet of metal is upright in between? Physically, there is only one possible explanation: this armor was bent around the already flattened cylinder. The reports have no answer to this question. It was simply passed over by FFM/IIT so as not to jeopardize the preconceived conclusion.

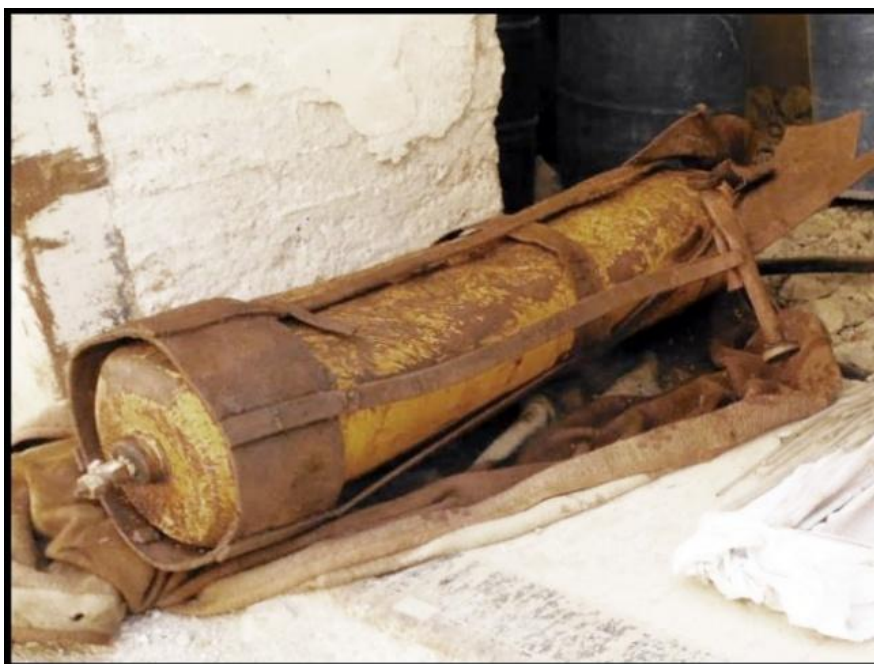
However, there is another problem associated with the slipped armour. The valve protruded unprotected from the armour, while this cylinder was to cut horizontally through the reinforced concrete of the roof a microsecond later. The valve remained completely undamaged.

There have been a number of explanations, but they are just as fantastic. One theory claims that the cylinder hit the back side first and then rotated through the crater. In this theory, the cylinder with the fins fell forward, which is explained by wobbling during the fall. However, rotating through the concrete ceiling would also shear off the valve. Another theory claims that the concrete immediately broke over a large area, allowing the valve to rotate freely through the open hole or fall. However, this would mean that the crater would have to have at least the length of the cylinder of 1.4m plus the length of the valve. In addition, the rear end would have to be completely stopped by the roof, while the same roof at the front end would break so quickly and widely that the valve could rotate through unhindered. It also assumes that the chunks of the broken roof are accelerated fast enough to get out of the way in time.

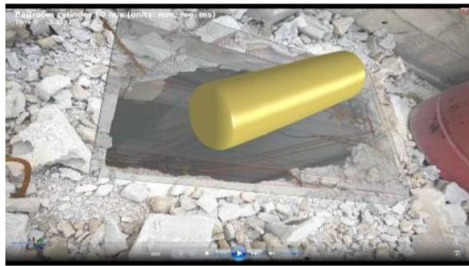
**FIGURE A.7.6 SNAPSHOT OF SIMULATION OF THE POSSIBLE ROOF CRATER FORMATION**

Considering the proximity of the water tank, the neighbouring buildings, and the surrounding wall adjacent to the hole in the roof, it was concluded that the cylinder impacted the roof as shown in Figure A.7.6. From the shape of the crater and damage on the cylinder, it is likely that the cylinder landed parallel to the ground creating a crater with dimensions of approximately 166 x 105 cm, which is in keeping with the dimensions of cylinder of 140 x 35 cm. It should be noted that the cylinder had an additional structure attached to the body, which is still in line with the dimensions of the crater. The damage observed on site by the FFM team and the possible trajectory of the cylinder based on observed damage and numerical calculations are represented in Figure A.7.7.

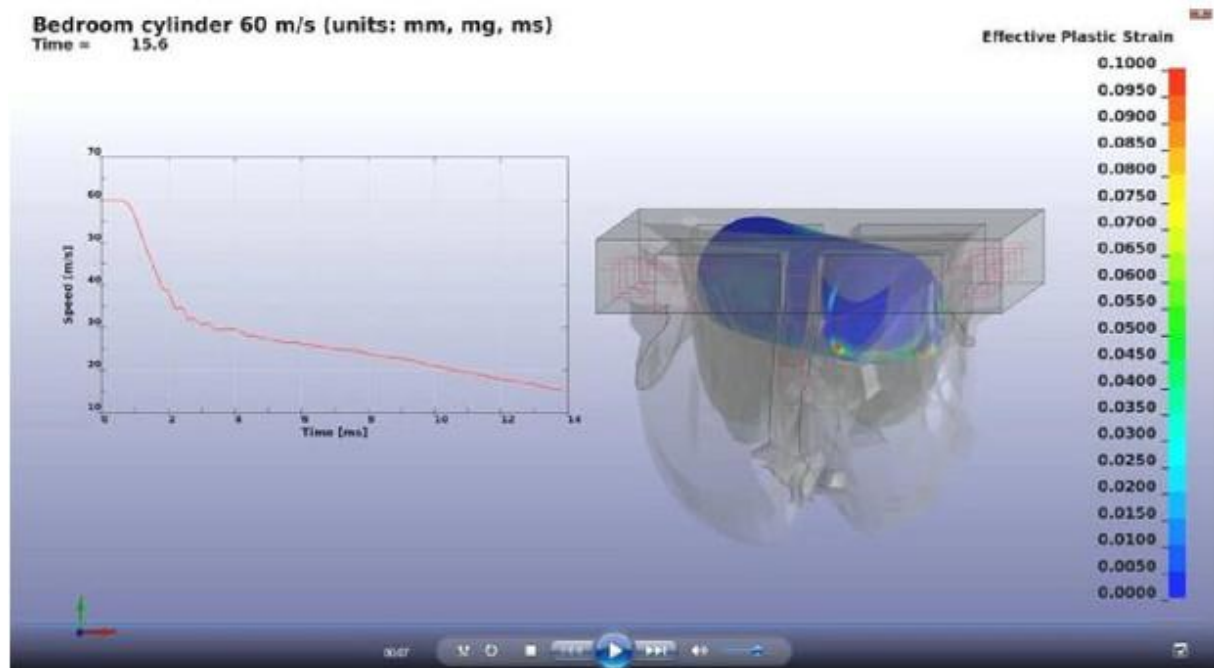
To illustrate the deformation of the horizontal cylinder, the FFM report shows a screenshot of a finite element analysis, but without further explanation. According to this illustration, the cylinder falls to the roof at 60m/s, is decelerated to about 30m/s in 3 milliseconds and then falls another 11ms with constant deceleration. The speed decreases linearly until it reaches 15m/s. At this point, the timeline is cut off. The picture to the right of the speed graph shows the cylinder after 15.6ms supposedly in a comparable deformation.

Without going into too much detail, the graph means the following: A 280kg cylinder with a kinetic energy of 504kJ is decelerated to only 15m/s in a total of 14 milliseconds. The force required for this is **900kN**.

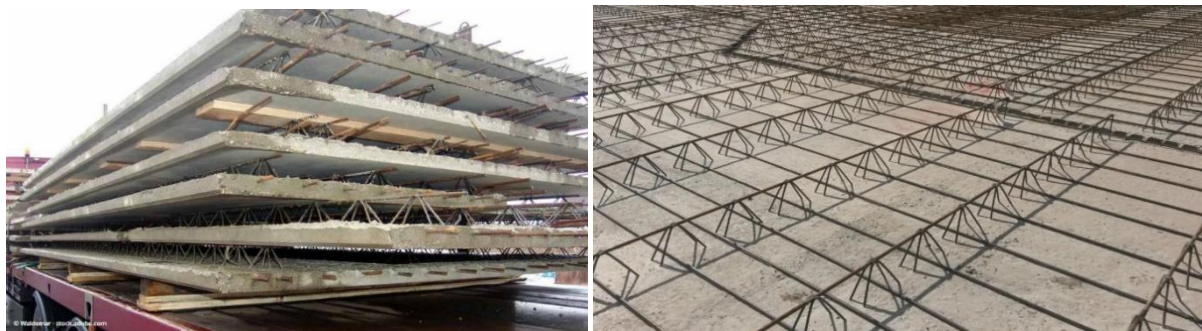
We are talking about a 20cm thick roof and a roof shape, which is called a "fragile ceiling" in Europe. These are pre-formed roof elements with embedded reinforcing steel, which are brought into position and poured with concrete.

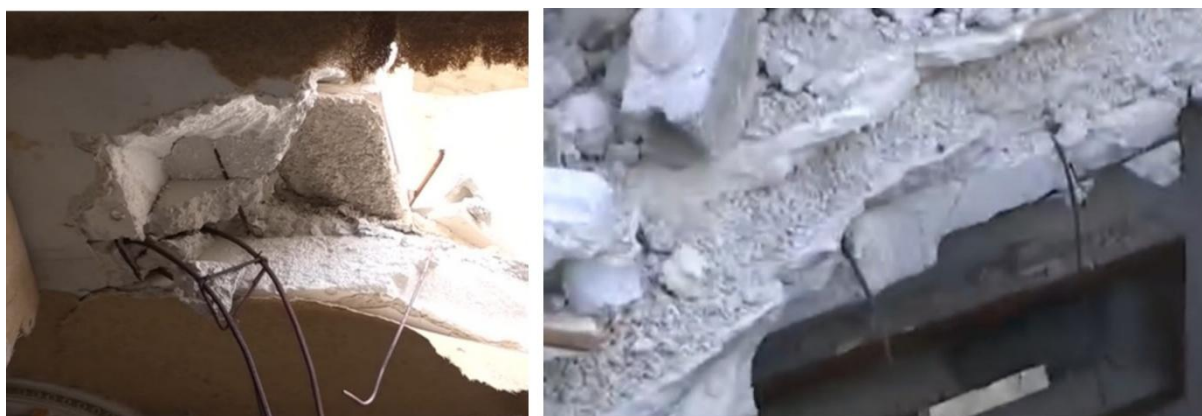
Furthermore, it is noticeable that the Syrian concrete is almost white and at the fractures is more reminiscent of gypsum or chalk than of super-solid concrete.

Above this layer of about 15cm thick white concrete with steel reinforcement lies a porous layer that has almost dissolved between the concrete and the floor tiles above. This layer is most likely polystyrene sheets for thermal

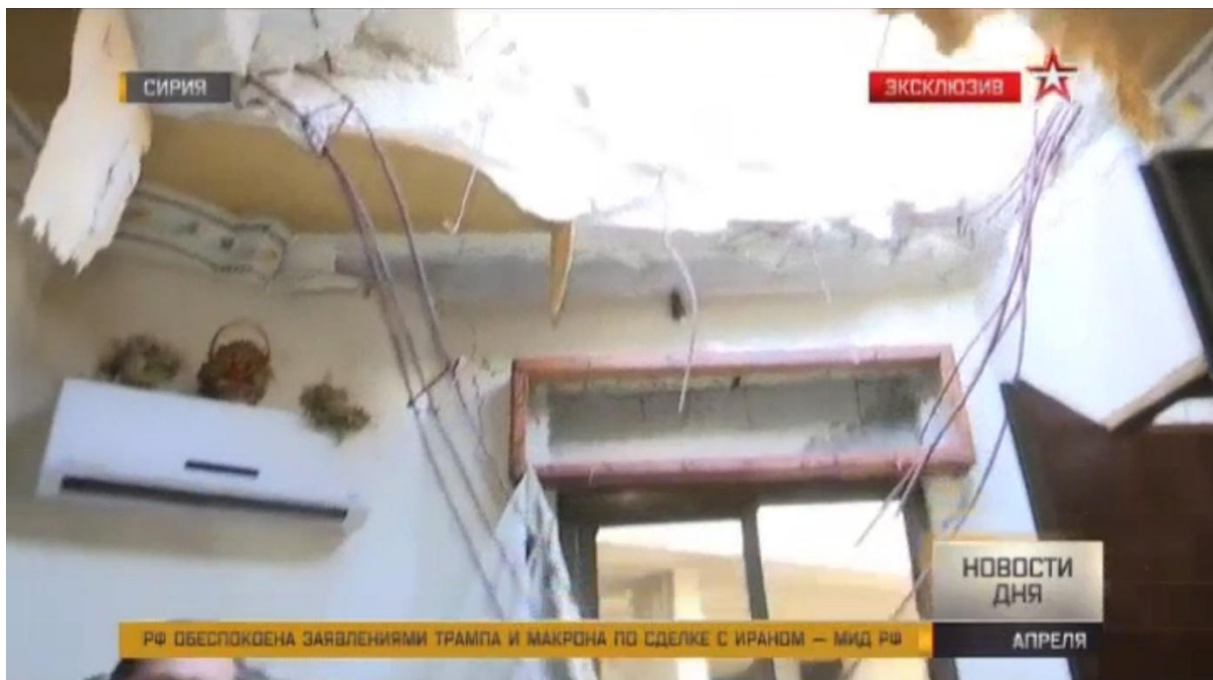
In other words, this cylinder has long since passed the 20cm thick roof. Since then, all interaction has taken place exclusively with the reinforcing steel, but neither the cylinder nor the armour shows the slightest trace of this tremendous interaction. It is not even clear whether the steel struts actually had to crack or whether the exposed ends lost all grip without the concrete and simply hang down.

Realistically, the Syrian flat roof with an optimistic 30kN energy absorption would have cost this 900kN floor about 7% of energy. After that, the cylinder would have fallen further at 57-58m/s, to the next floor.

Conclusion: A 20 cm thick concrete roof (whether reinforced concrete, filigree ceiling or gypsum concrete) cannot absorb 470 kJ. Even high-strength reinforced concrete (C60/75) would dissipate at most 50–100 kJ at 0.5 m indentation path before it breaks completely. The FEA must therefore have assumed an unrealistically high ductile-plastic energy absorption — i.e. the roof behaves like a thick metal buffer in the simulation, not like real masonry.

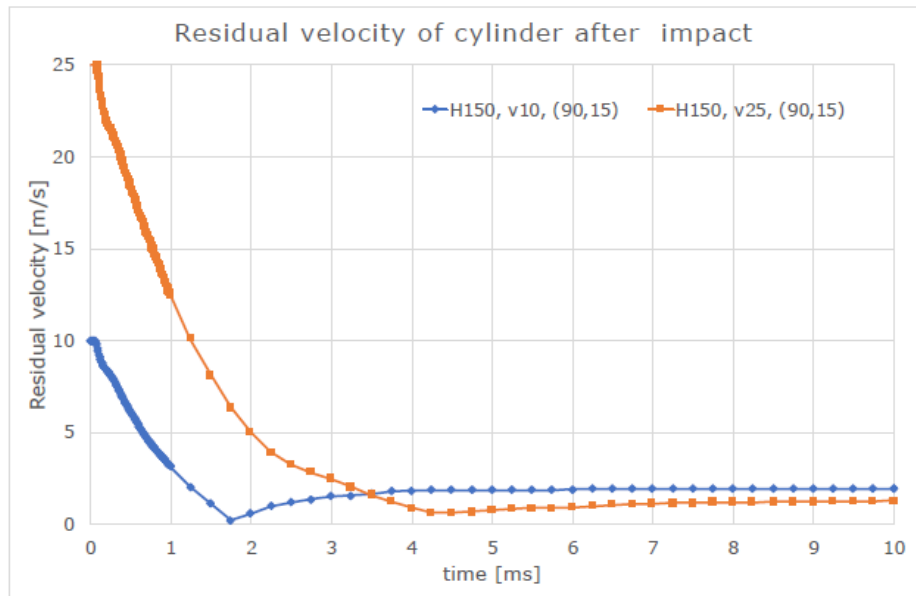
**FIGURE 12: DIAGRAM DEMONSTRATING THE POSSIBLE MOVEMENT OF THE CYLINER AT LOW SPEED**

The diagram deals with two cases for the impact of the cylinder on the floor below. The Orange case starts with an impact velocity of 25 m/s, the Blue case begins with an impact velocity of 10 m/s. Case Blue thus describes exactly the scenario of a cylinder being thrown from the neighboring roof.

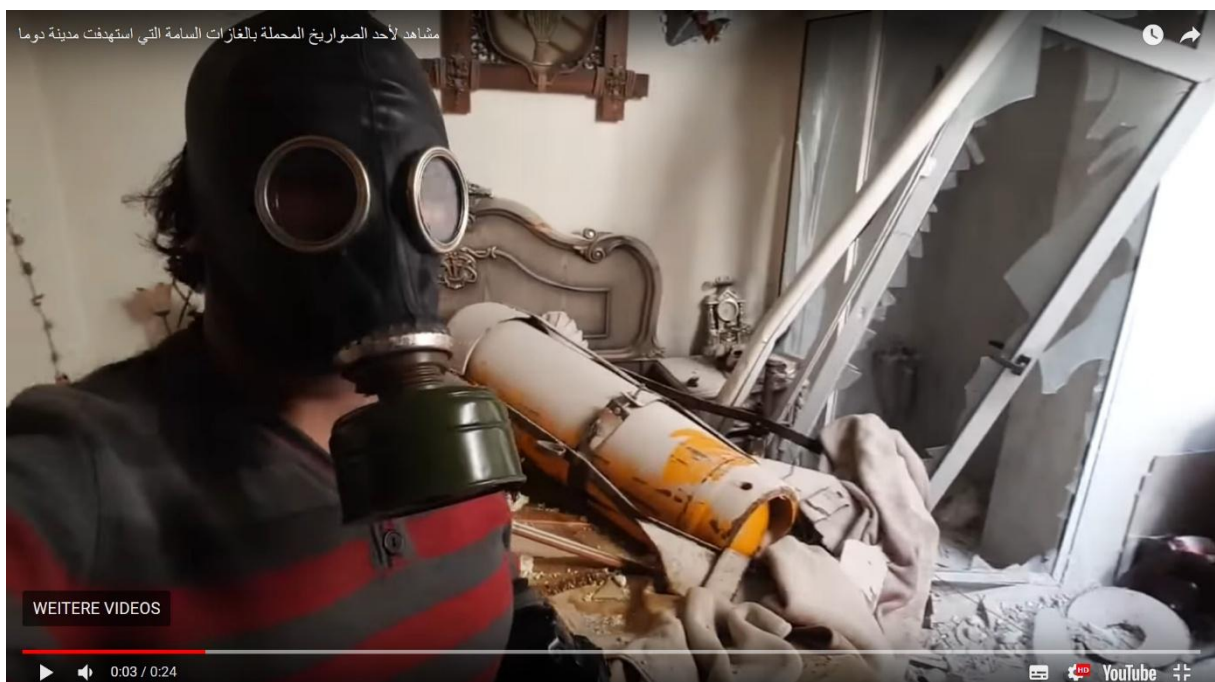
This cylinder could not even have reached the shower cubicle, which is impressively evidenced by the stacked glasses on the cubicle. Instead, a fine layer of snow-white dust has settled on the cylinder, which is completely missing on the bed right next to it. And the fins were initially wrapped in a blanket, as if the jumping cylinder had wrapped itself in the carpet on its way through the room and dragged it with it.

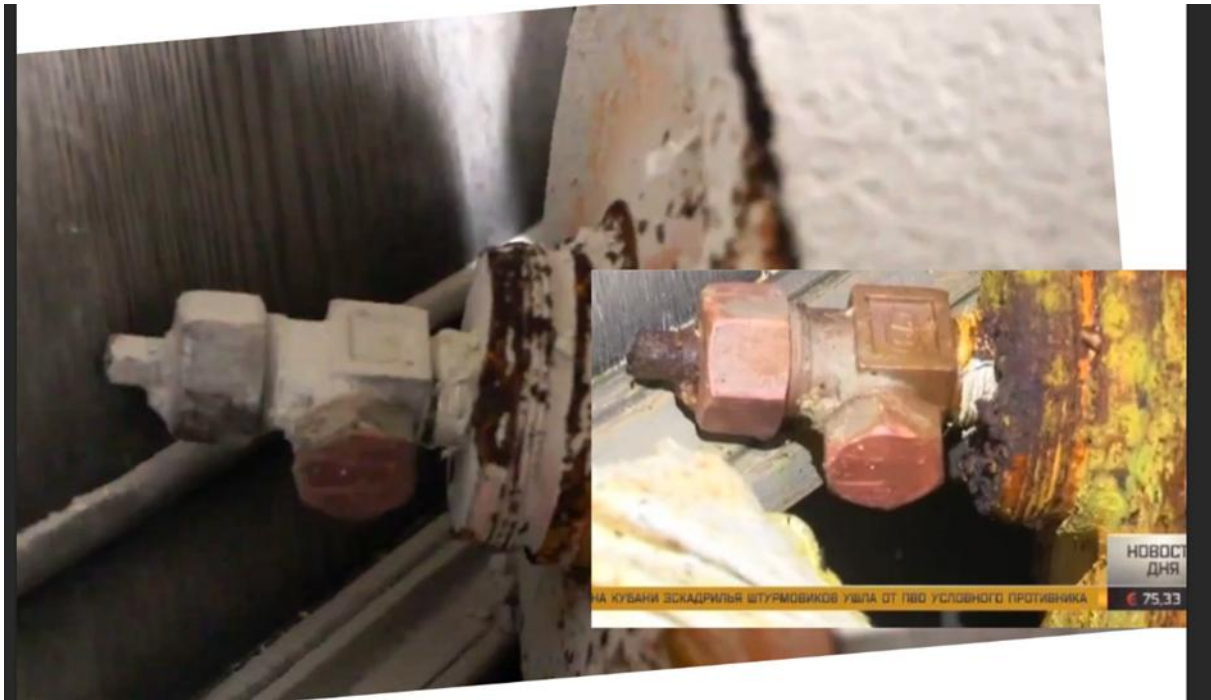
The fatal thing about this timeline is that it cannot be explained physically. When the first media activist shot his video after 8 hours, the red brass valve was white. This means that it was frozen from the evaporation of the escaping gas.

Despite the high thermal conductivity of brass and gas-tight closure - i.e. good thermal contact - the cap was red, i.e. warm. Despite close-up and original sound with birdsong, there was no hissing of a gas audible.

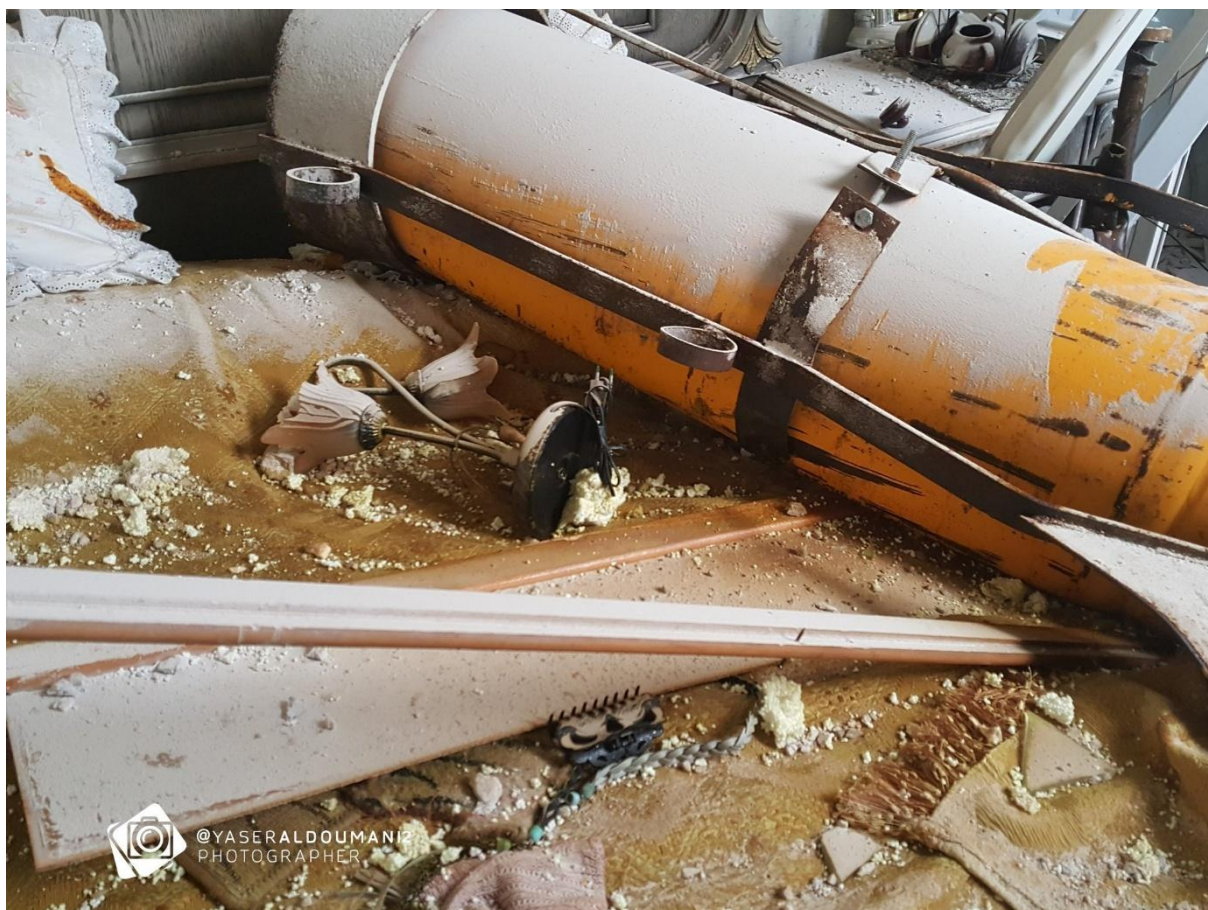
The discovery of bornyl chloride in samples from the wooden board under the cylinder was celebrated as striking proof of the presence of molecular chlorine  $Cl_2$ , especially by those who dismissed all the contradictions in the physics of the process described up to this point without hesitation. It should therefore be noted as a side note that this board is also not due to the destruction caused by the impact of the cylinder. Even if there is no trace of fine white dust on the board, it must have been on the bed before the cylinder jumped on it.

If you now find bornyl chloride in the samples from that board, you cannot automatically conclude that it can only have been produced by chlorine gas. Just a few years ago, wood preservative formulations with chlorophenols, chlorinated paraffins or chlorinated terpenes were quite common, and the furniture in this room is obviously older.
