The Fall and Jump of the

# Douma Bed Cylinder

An emblematic case study in 9 steps

by Michael Kobs

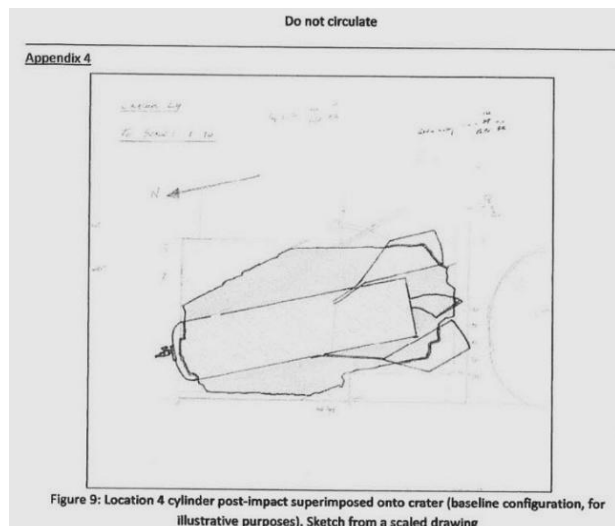
Presumably, these measurements come from the sketch of OPCW Inspector Ian Henderson, even if the ratio of 166:105 cannot be found in the sketch. In a scaled model, the sketch nevertheless proves to be accurate with regard to the upper edge of the crater, but neglecting deeper layers, some of which protrude quite far into the crater – i.e. reduce the actual breakthrough.

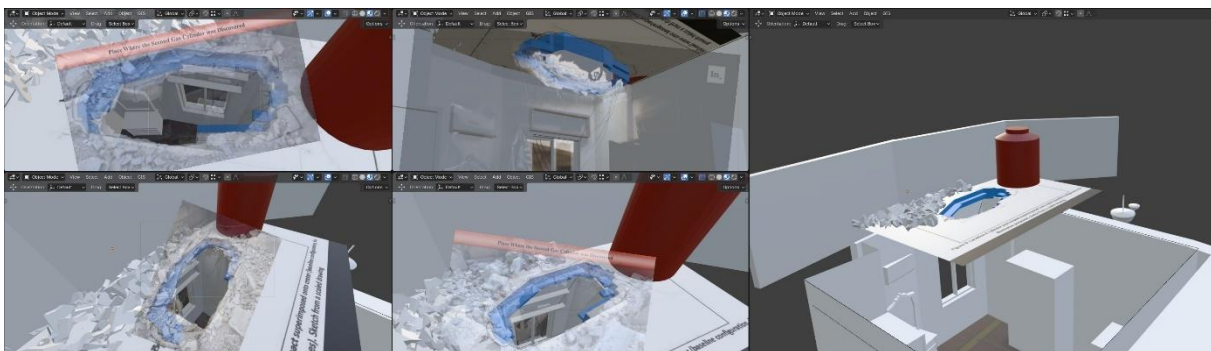
In this scale, which is in good agreement with the photographic evidence, it can be seen that the 166cm given in the FFM report obviously does not refer to the crater, but to the width of a box with measurements, which unfortunately cannot be read in the leaked "Engineering Assessment of Two Cylinders Observed at the Douma

Incident" due to the poor image quality. In the correct scale, this box is then 1.66 meters long and the cylinder corresponds to its standard size of 1.40m with a diameter of 0.35m.

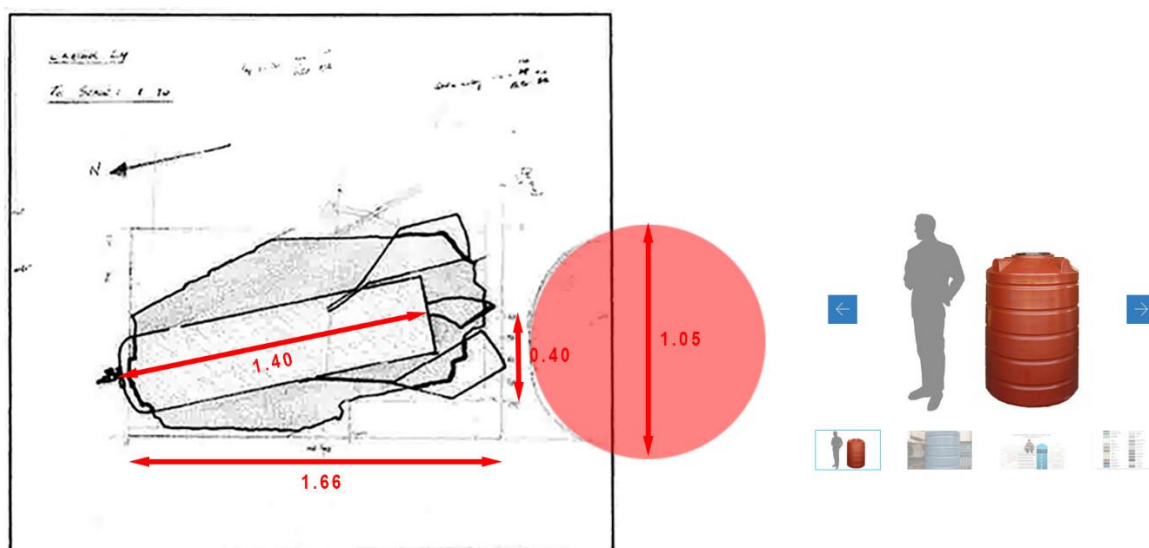
However, the Henderson sketch makes perfect sense if the cylinder is 1.40m long, the dimensioned box is labeled 1.66m at the bottom, the regular dimensions on the right side of that box represent a 10cm grid, and 1.05m is nothing but the standard diameter of a red 1200L water barrel, which is only hinted at in the sketch. The hardened OSINT investigators simply didn't want to entertain such an innocent interpretation. In essence, that entire effort only served to 1) interpret the crater as much larger than it obviously was and 2) then shrink the cylinder in relation to that hole.

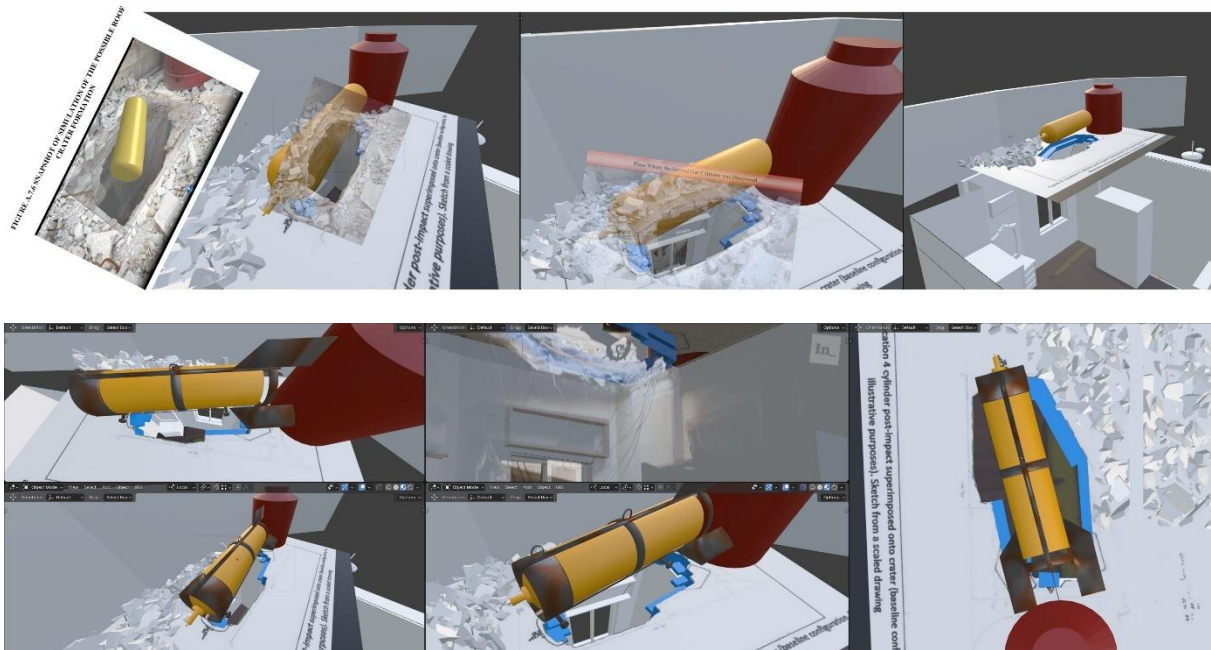
The FFM report went even further in the free interpretation of the dimensions. A photograph, which was already very distorted in perspective, was additionally stretched to about 150% of its width and a dwarf-like yellow cylinder without valve and armour was depicted above it. The undistorted photo can be found in the IIT report.

The true relation of the cylinder to the armour naturally raises the question once again as to how the cylinder could have hit the roof horizontally and fallen or rotated through the actual hole, especially with the armour displaced and the valve exposed.

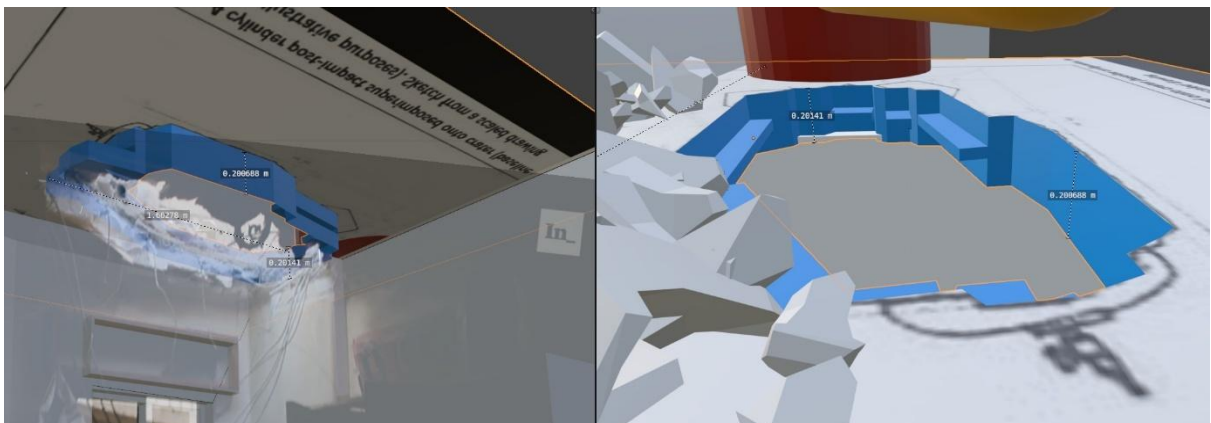
From the scaled model, the thickness of the roof can be read from about 20cm, which is essential for further consideration.

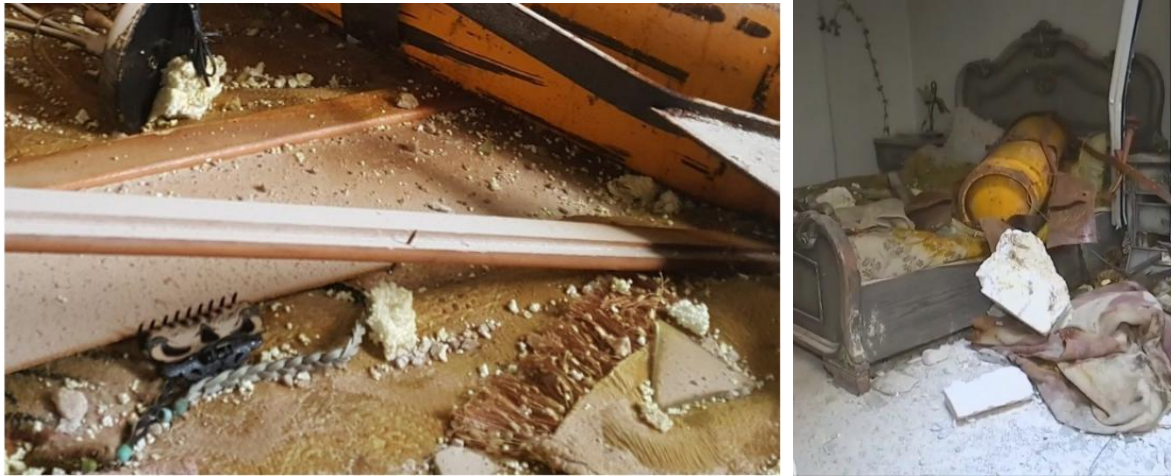
Above this layer of about 15cm thick white concrete with steel reinforcement lies a porous layer that has almost dissolved between the concrete and the floor tiles above. This layer is most likely polystyrene sheets for thermal

insulation. Chunks and flakes of polystyrene lay on and around the bed. An amazingly large piece even leaned against the fin of the cylinder.

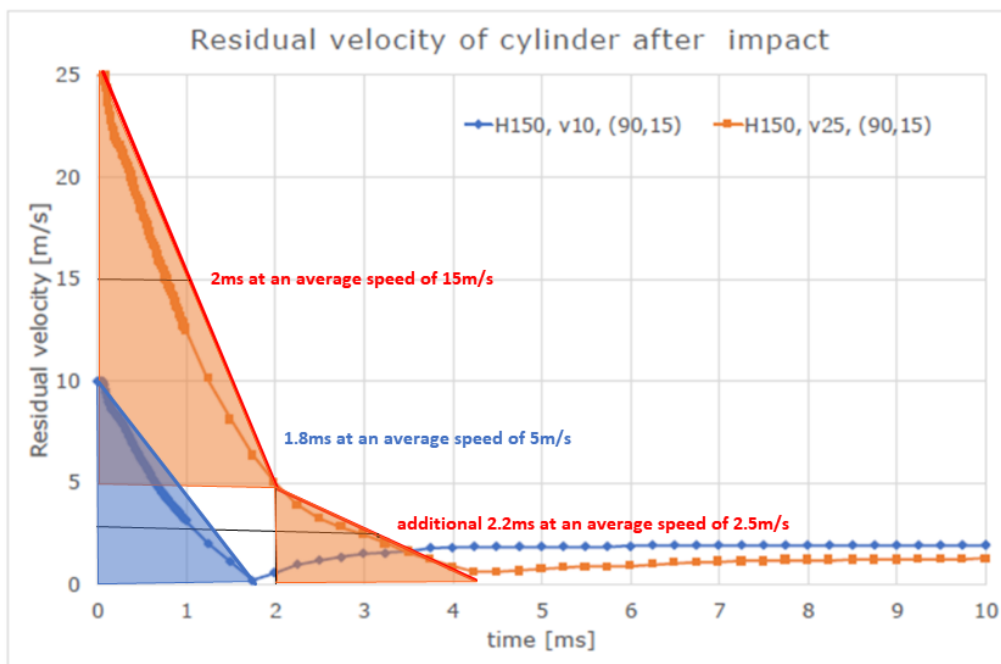
From the moment of impact to the stop, the cylinder moves for 1.8 ms at an average speed of 5 m/s in the blue case. In the case of Orange, it moves for 2 ms at an average speed of 15 ms, and then another 2.2 ms at an average speed of 2.5 m/s.

This means that in the case of blue, the cylinder penetrates 9mm deep into the ground or is compressed due to its elasticity. In the case of orange, it penetrates 35mm deep into the soil or is compressed. The bend in the curve of orange means that the cylinder reaches the limit of its elasticity and begins to deform.

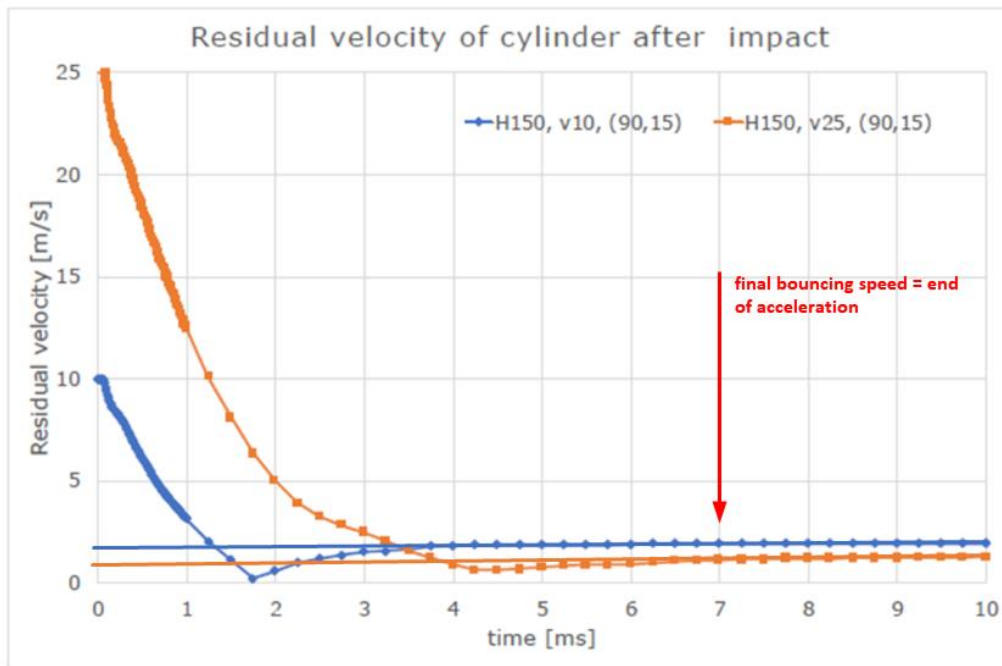
After the cylinder reaches a standstill, it then springs back due to its elasticity. Since the cylinder has not yet reached its limit of elastic deformation in the blue case, it subsequently jumps a little higher, with a residual velocity of about 2m/s. In the case of orange, the residual velocity is only about 1m/s.

The cylinder in the Orange case could therefore jump 50mm high if it jumps vertically. In order to achieve a maximum distance, it would have to lift off the floor at a 45° angle. In this case, however, it would only reach a height of 25mm, but could jump as far as 102mm.

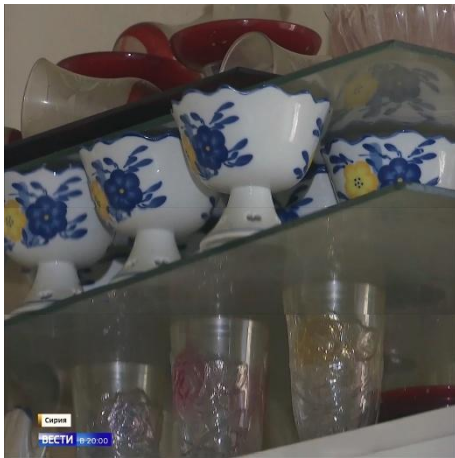
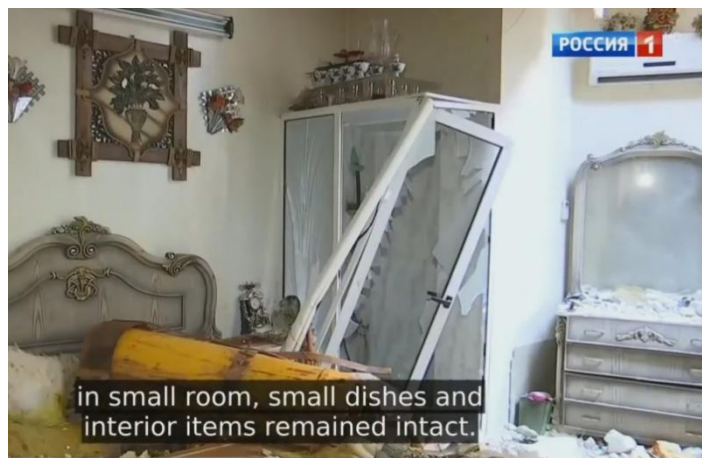
This cylinder could not even have reached the shower cubicle, which is impressively evidenced by the stacked glasses on the cubicle. Instead, a fine layer of snow-white dust has settled on the cylinder, which is completely missing on the bed right next to it. And the fins were initially wrapped in a blanket, as if the jumping cylinder had wrapped itself in the carpet on its way through the room and dragged it with it.

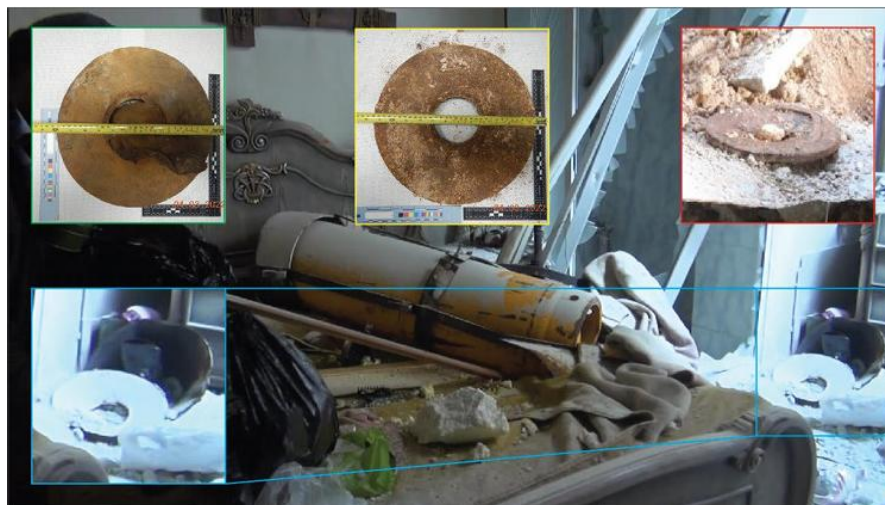
**FIGURE 16: COMPARISON OF METAL FRAGMENTS RECOVERED IN LTAMENAH (25 MARCH 2017), SARAQIB (4 FEBRUARY 2018), AND DOUMA (7 APRIL 2018)**

However, if there is one thing that can be said with certainty, it is that this object was not flat. In addition, there is neither a meaningful use for a disc on the harness, nor has there ever been a break on a harness where this disc could have been attached. The conjecture is that this disc was attached to the front of the harness to protect the valve, while the entire design is designed to allow the valve to break off on impact. Aerodynamically, a disc-shaped windshield would also increase the air resistance at the front.

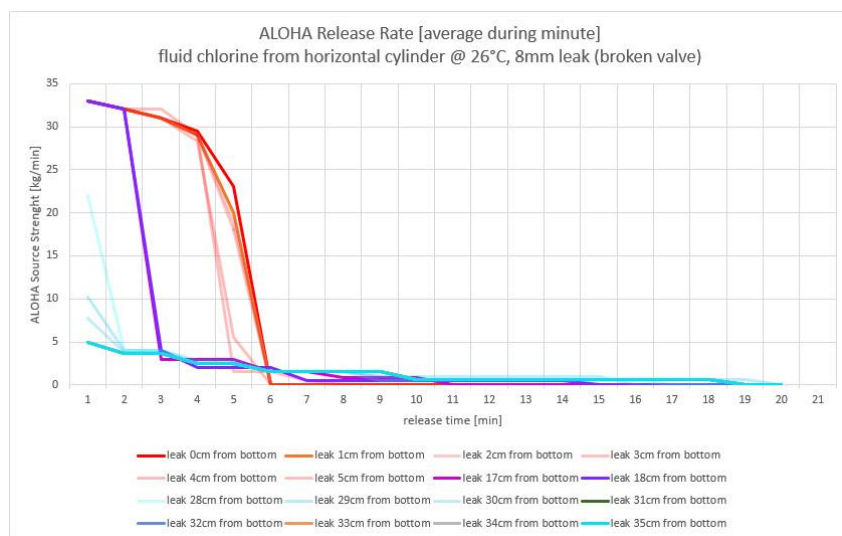
8 hours after the alleged attack – the creation of the leak - only the red and therefore warm outlet cap could be an indication of how a green chlorine lake could form after 8 hours on a frozen bed and without hissing.

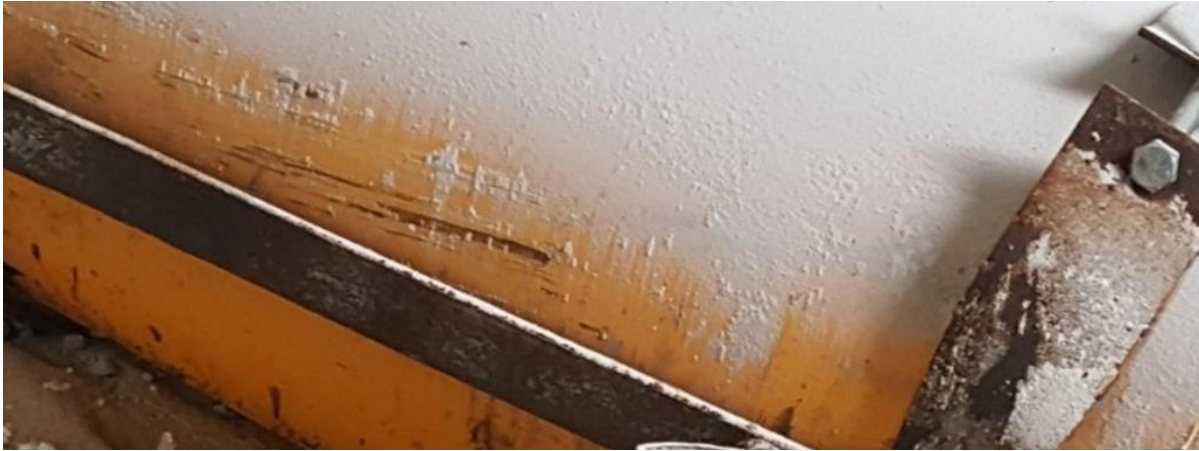
In the afternoon of the same day, Al-Doumani filmed his video. The cylinder was neither iced over nor had condensation settled from the air. The fine lime dust on the cylinder had not run down with water drops. In other words, the cylinder had never gotten cold enough up to this point, no visible gas, no hissing.

Condensate formation begins at a withdrawal of 0.5% per hour in relation to the liquid filling quantity. With this cylinder that would be 600 grams per hour. Over 8 hours, that would be 7.2kg or 2.25m<sup>3</sup> of chlorine gas. At this amount, the cylinder would empty completely over 25 hours without condensation and hissing.

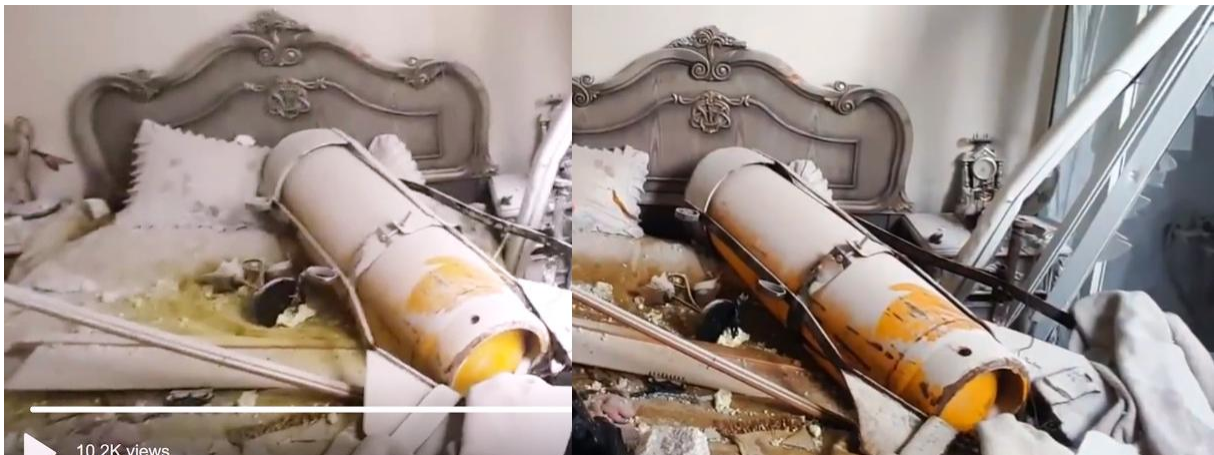
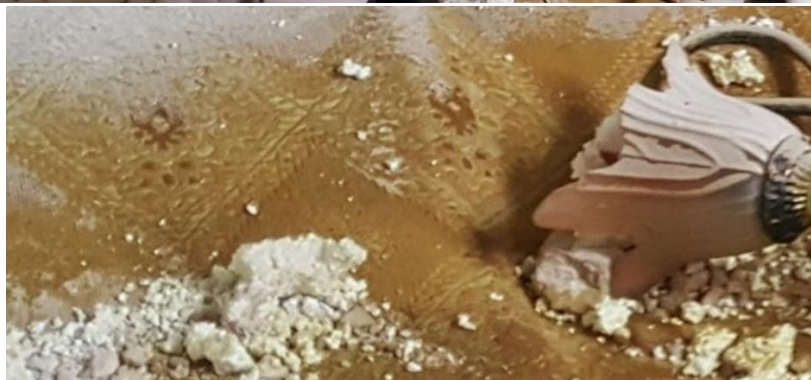
It wouldn't start hissing after 48 hours. The amount would be too small to create a visibly yellow concentration, which also piles up above the duvet instead of sinking down to the floor. This amount would be orders of magnitude too small to extract so much heat from the atmosphere above the bed that the brown duvet appears white. Frost would be the only plausible explanation for the magical color change of the duvet (or digital image processing) but would require the short-term release of a large amount of chlorine vapor – short enough that the cylinder does not cool below the dew point and long enough to freeze the bed and valve by evaporating chlorine.

The cause of this mysterious color transformation, as well as the obvious contradictions in the timing of this cylinder emptying, was ignored by FFM and IIT alike, as they only allow the conclusion of some kind of manipulation.
